Subpart C - Buildings and Facilities

(21 CFR 211.42 – 211.58)

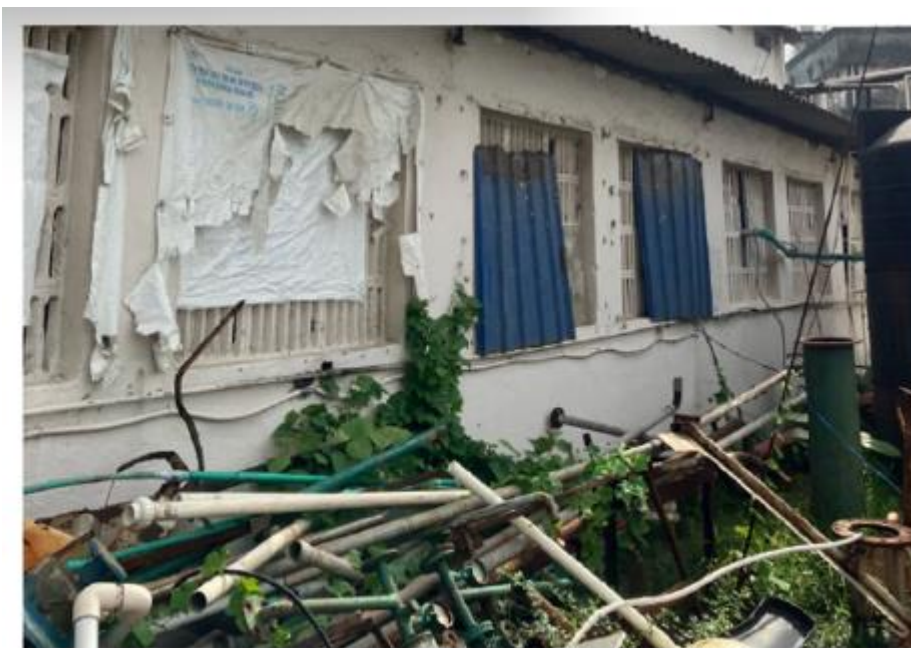
- Harborage areas immediately outside the first floor of the facility where filling, packaging, and (b)(4) production operations are performed. This area consisted of discarded piping with window-grate openings to the exterior of the facility.

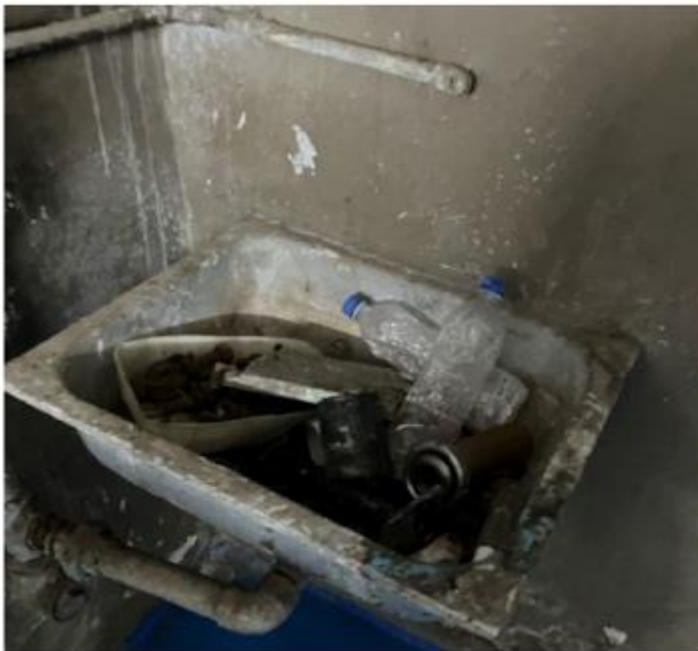
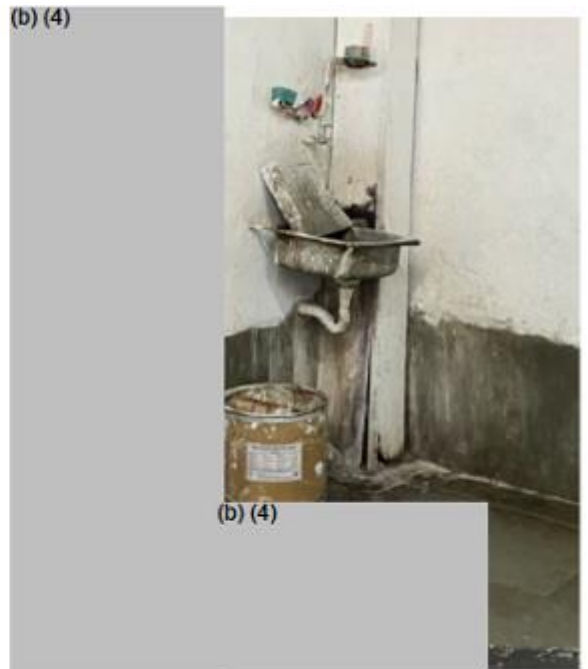
- Sinks in the production area used as a source of water for cleaning production equipment.
